Effects of Concentrated Hydrochloric Acid Spills on Aircraft Aluminum Skin

July 1998

DOT/FAA/AR-TN97/108

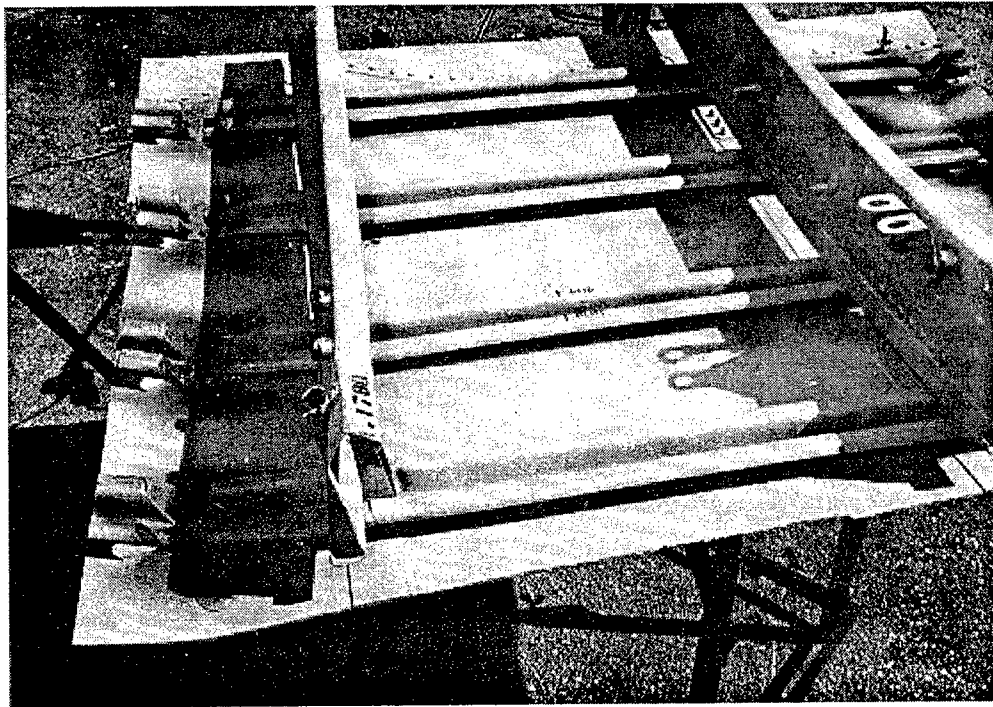
The first test was the largest, a 3- by 3-foot section with a 1-liter acid spill (figures 1 and 2). The edges of the skin were bent upwards to contain the acid. In the process of bending the skin and cutting notches in the ribs to allow the bending of the frame, scrapes and breaks in the surface coating of the aluminum skin were produced. There was no treatment of the marred surfaces in this test. The acid contacted not only the interior skin surface but also the bulkhead plates and fittings and the ribs and attaching grommets.

FIGURE 1. TEST ARTICLE FOR TEST 1: 3- BY 3-FOOT SIDEWALL OF A BOEING 747

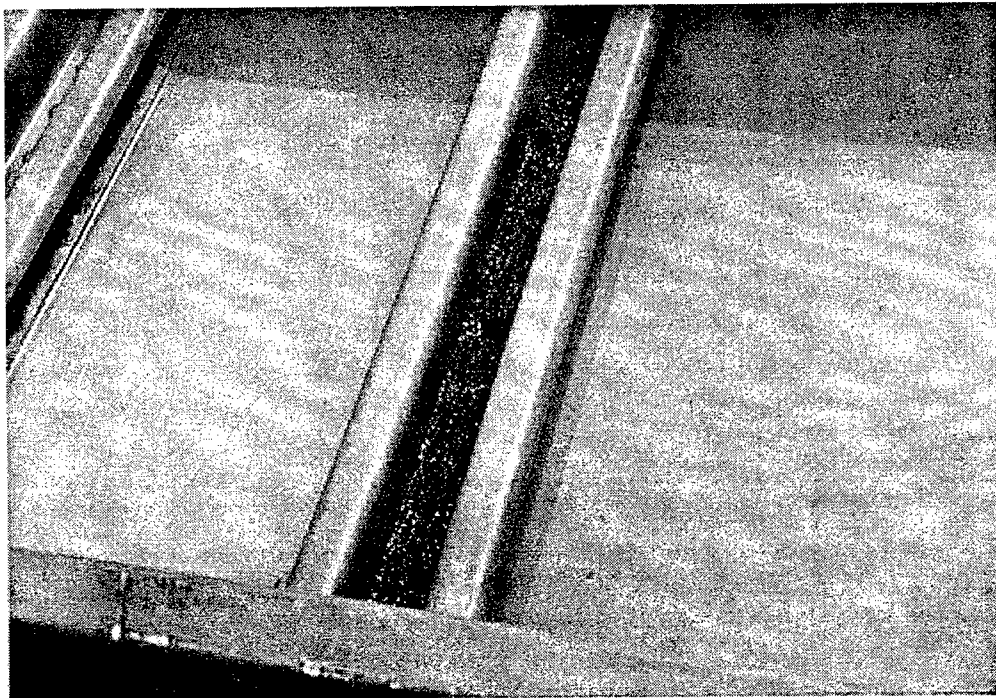
FIGURE 2. TEST 1 IN PROGRESS WITH A 1-LITER SPILL OF CONCENTRATED HYDROCHLORIC ACID

Test No.	Test Article Description	Location of Failure	Time to Failure (min.)	Comments	Figure No.
1	3' x 3' section of fuselage	At scratched surfaces and at bends in skin At rivets	47, 65, and 80 No failure	Acid created hole in skin at scratched and bent surfaces. Rivets partially decomposed, but still intact.	1, 2
2	6" x 6" section of aluminum skin in a 7" x 7" Pyrex pan	At rivets At ribs At rivets	50 70 80 85	Three rivets eaten away below surface of skin. Side of rib eaten 1/2 inch through the length of rib. Severe corrosion. All submerged surfaces of unpainted rib completely gone. Only white exterior paint remained where rivets were.	3
3	7" x 7" section of aluminum skin as base of pressurized box, 0-2.5 psi. Silicone caulk used as a seal.	At rivets At ribs	N/A 90	Severe corrosion. Rivets eaten through below surface of the skin. Rib disconnected from aluminum skin. All submerged surfaces of unpainted rib completely gone. Base seal remained intact. Pressure not maintained during the test due to failure of lid seal.	4, 5, 6

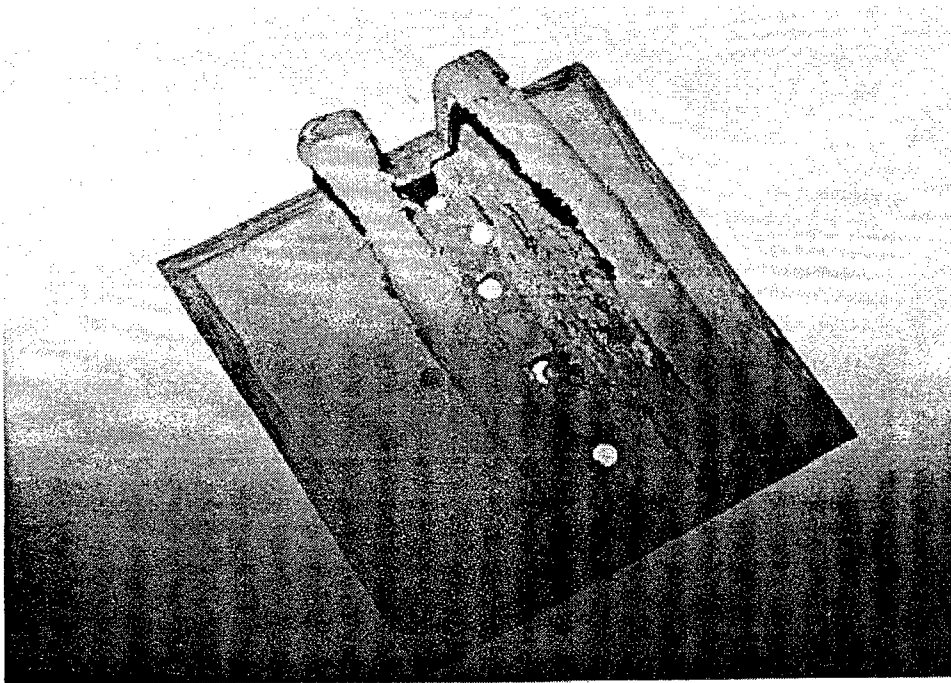
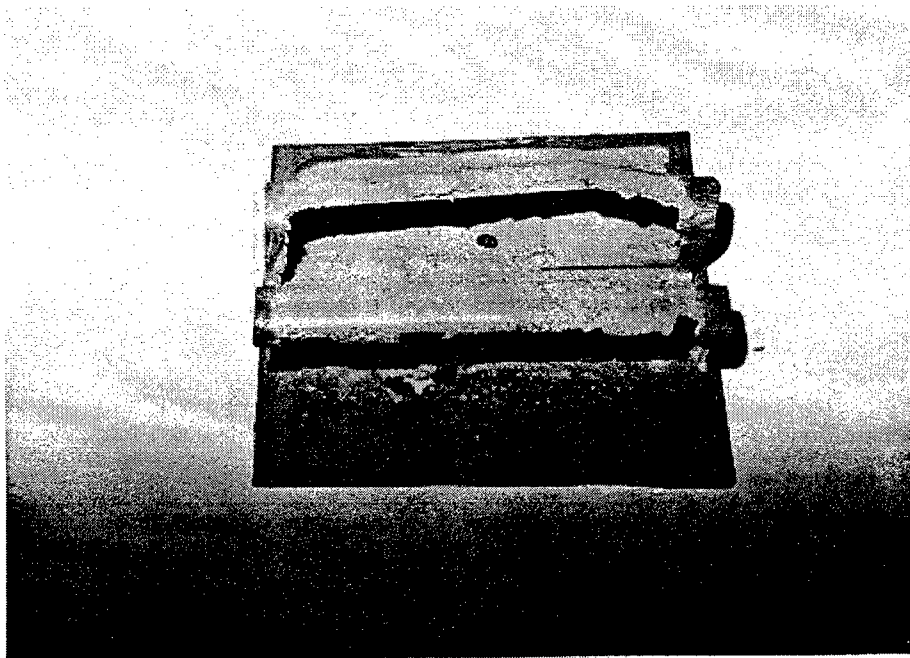
A 6- by 6-inch section of the skin, including the frame material, was placed in a Pyrex pan with the outside surface of the skin face down. All cut edges of the test sample were covered with epoxy paint. One liter of concentrated HCl was spilled into the Pyrex pan. The depth of acid was 1 1/4 inches. Periodically the section of skin was lifted out of the solution with metal tongs to visually evaluate the damage as a function of exposure time. The test specimen was rinsed with tap water at the conclusion of the test and photographed (figure 3).

FIGURE 3. TEST ARTICLE FOR TEST 2 AFTER REMOVAL FROM PYREX PAN CONTAINING 1 LITER OF CONCENTRATED HYDROCHLORIC ACID, TWO VIEWS

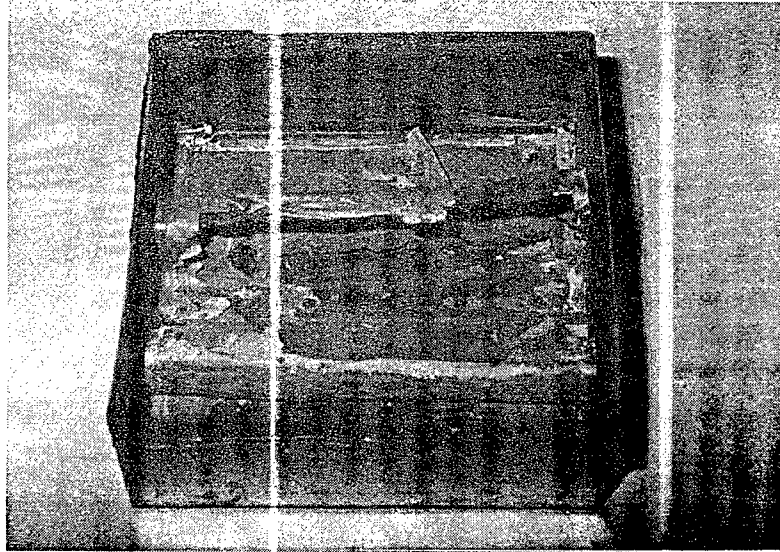
FIGURE 6. TEST ARTICLE FOR TEST 3 AFTER A 90-MINUTE CONTACT WITH SPILLED CONCENTRATED HYDROCHLORIC ACID. TOP OF TEST CONTAINER REMOVED.

A 2.5 psi box pressure simulates the ΔP_{skin} at 15,000 feet altitude. A small ΔP may result in the blowout of the white exterior epoxy paint on the bottom of the box when the rivets fail, giving a visual indication of failure. However, the silicone lid seal failed early into the test and pressure fell to ambient.

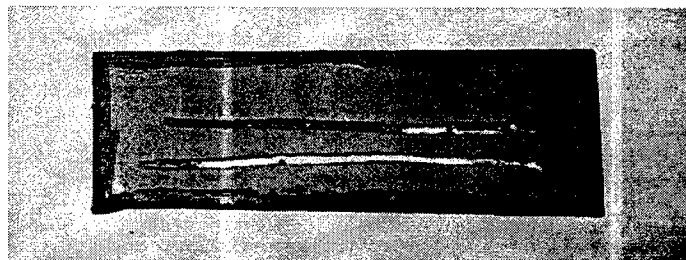
FIGURE 7. TEST ARTICLE FOR TEST 4. SCRATCHED B-747 SKIN AFTER REMOVAL FROM PYREX PAN CONTAINING 1 LITER OF CONCENTRATED HYDROCHLORIC ACID.

4	One scratched strip of aluminum skin, 2" x 6 3/4" in a 7" x 7" Pyrex pan	At scratches	60-90	Acid created hole through the aluminum skin along the scratch. The white exterior epoxy paint was wrinkled, but the seal remained intact.	7
